# AIR DISC BRAKE ROTOR

**FLEETX<sup>®</sup>**

## DISC BRAKE ROTOR INSPECTION

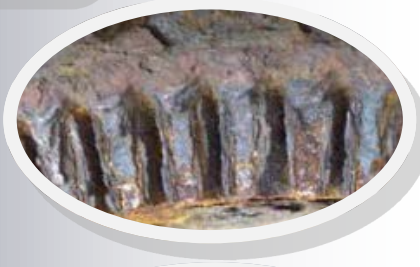
*Uncoated rotors leaves the ABS ring vulnerable to rusting and causing ABS sensor to faults. This causes premature replacement and increase maintenance cost*

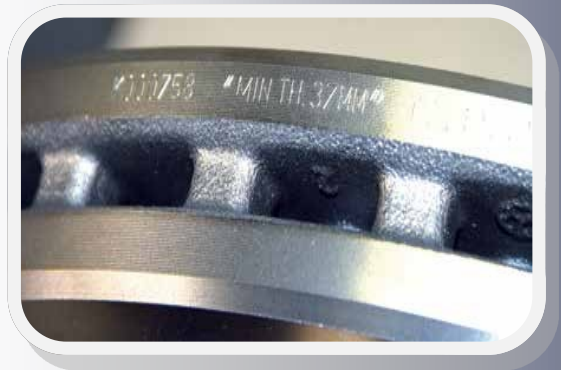
Identification  
FIGURE 1

FleetX rotors can be identified by part number. The part numbers and minimum thickness are cast or stamped into the rotor as shown in figure 1. Some may have a bevel edge. The inside bevel indicates minimum thickness has been reached.

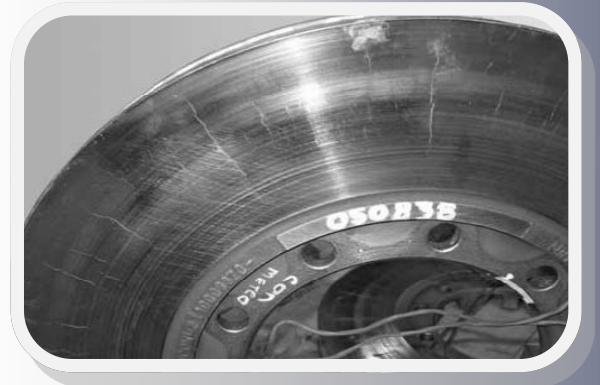
Blue Marks  
FIGURE 7

If the rotor has become extremely hot, the braking surface may exhibit blue marks or bands. See figure 7 for examples of these marks. This condition may be caused by continued hard stops, improper brake balance, improper brake caliper clearance, operation, or adjustment. The cause of overheating should be determined and corrected. It is not necessary to replace the rotor as long as it meets the proper dimensional specifications for runout and thickness.

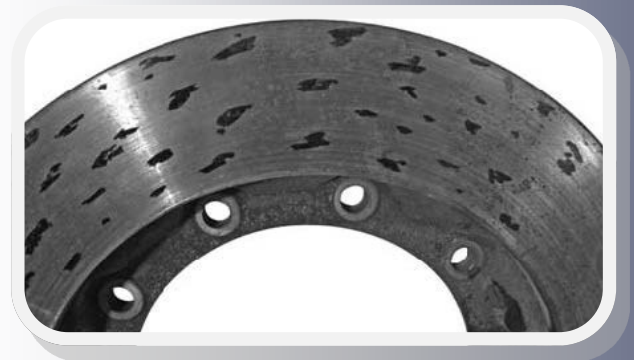
Martensite Spotted Rotor  
FIGURE 9

Rotors subjected to extremely high heat followed by rapid cooling can exhibit a Martensite Spotted condition. This condition appears as black spots on the rotor that are slightly raised and are hard and brittle. See figure 9. The high temperatures cause a structural change to the rotor material. This condition can make the rotor more susceptible to cracking. Rotors with this condition should be replaced. Check the brake linings for uneven wear and replace as necessary. After the rotor has been replaced, and the hub and rotor reinstalled onto the axle, the brake system should be checked for brake drag and proper brake balance.

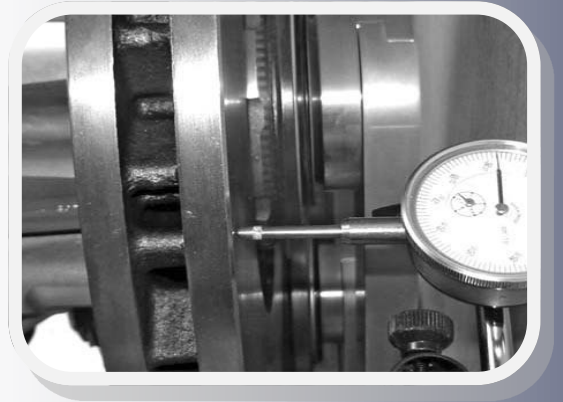
Lateral Runout  
FIGURE 13

Lateral runout, or wobble, on the rotor braking surface should not exceed 0.020" in one full revolution of the rotor. The measurement should be taken with a dial indicator at the center of the rotor braking surface. See figure 13 for proper runout measurement set up. The runout measurement should not include end play of the wheel bearings. If the runout measurement is over 0.020", the end play of the wheel bearings should be checked. If the wheel bearing end play is greater than the manufacturer's recommendations, the wheel bearings should be adjusted per the manufacturer's recommendations.

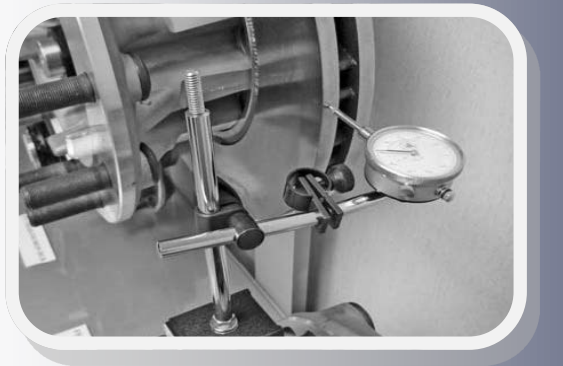
Radial Runout  
FIGURE 14

Radial runout on the outside diameter of the braking surface should not exceed 0.035" when checked with a dial indicator. See figure 14. If the runout exceeds 0.035", the rotor should be replaced.

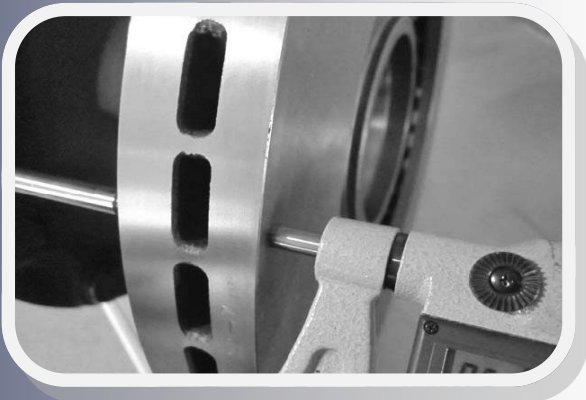
Top of Rotor  
FIGURE 15

The rotor thickness should be measured at three points using a micrometer as shown in figures 15. If the rotor thickness varies more than 0.005" between any two places, the rotor should be replaced.

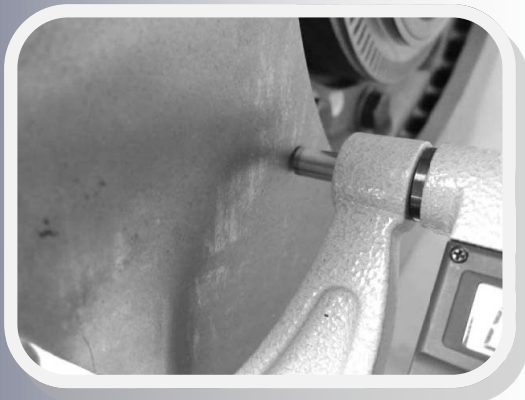
Bottom of Rotor  
FIGURE 17

The rotor thickness should be measured at three points using a micrometer as shown in figures 16 and 17. If the rotor thickness varies more than 0.005" between any two places, the rotor should be replaced.
